Manhole Inspection Summary

Manhole # S71Q__001MH

Insp Date: **4/15/08 9:35 AM**

Location Address: **6708 Bessemer Ave.**

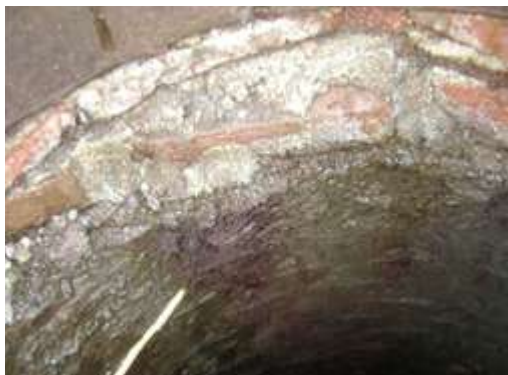
Defect 1

Condition: ☐ Sound ☐ Cracked ☐ Root Intrusion ☐ Loose Brick ☒ **Deteriorated**

Infiltration: ☐ None ☒ **Joint** ☐ Cracks ☒ **Mortar** ☐ Roots ☐ Wall

deteriorated mortar under frame

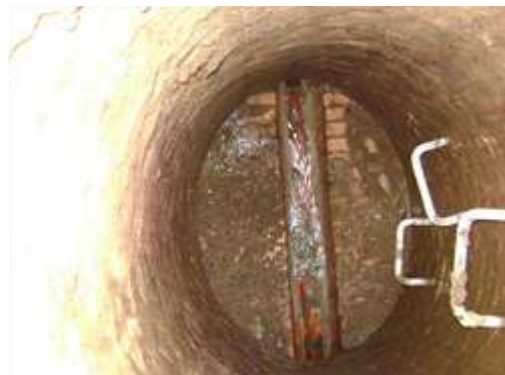
Defect 4

Condition: ☐ Sound ☐ Cracked ☐ Root Intrusion ☐ Deteriorated ☐ Leaks ☒ **Debris**

Debris on bench

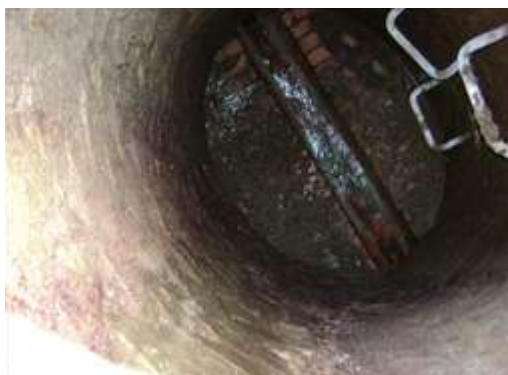
Defect 3

infiltration

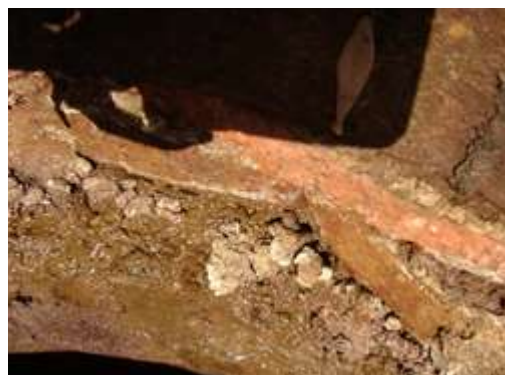
Defect 2

Condition: ☐ Sound ☒ **Cracked** ☐ Root Intrusion ☒ **Loose Brick** ☐ Deteriorated

Infiltration: ☐ None ☐ Joint ☒ **Cracks** ☐ Mortar ☐ Roots ☐ Wall

infiltration under frame

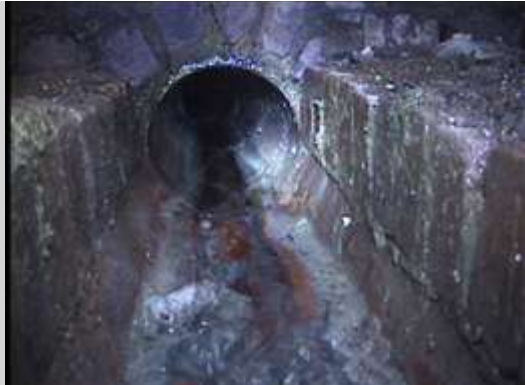
12 O'Clock Outflow

Pipe Height: **8.4** (in.) Rod and Bar (Angled)
Pipe Material: **Clay** ☐ Pipe Lined
Invert Depth: **9.00** (ft.) Flow Characteristics: **Fast**
Deposits: ☒ None ☐ Mud ☐ Sludge ☐ Debris ☐ Grease
Silt Depth: (in.) Deposits Extent:
Infiltration: **None** Pipe Seal Cond: **Sound**

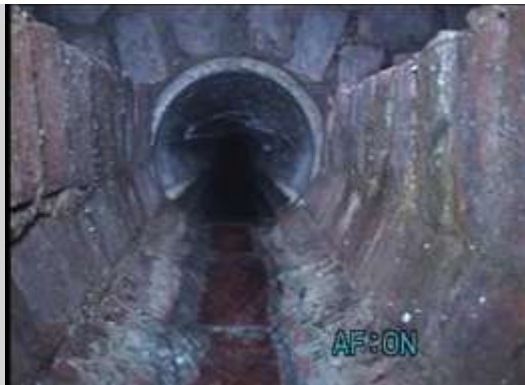
6 O'Clock Inflow

Pipe Height: **8.4** (in.) Rod and Bar (Angled)
Pipe Material: **Clay** ☐ Pipe Lined
Invert Depth: **8.79** (ft.) Flow Characteristics: **Fast**
Deposits: ☒ None ☐ Mud ☐ Sludge ☐ Debris ☐ Grease
Silt Depth: (in.) Deposits Extent:
Infiltration: **None** Pipe Seal Cond: **Sound**
